SSP GOES BUMPER TO BUMPER WITH GEAR PUMPS

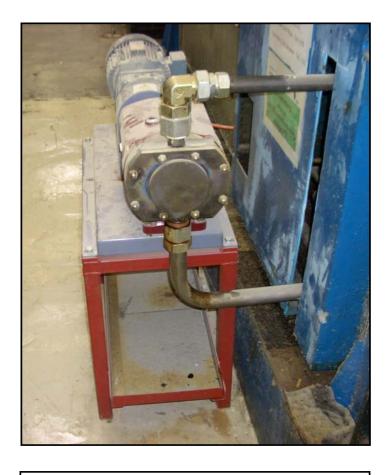
The SSP Series S rotary lobe pump has the ability to pump abrasive media with its non-contacting pumphead design. Pump specification was enhanced by the use of stainless steel bilobe rotors and plasma nitrided rotorcase and rotorcase cover. Both S3-0027-V15 and S4-0055-V20 pump models are being used for different flow rates.

Pump Range: Series S Model: S3-0027-V15

Flow Rate: 20 l/min
Suction Pressure: 6 bar
Discharge Pressure: 8 bar
SG: 1.25 - 1.30
Viscosity: 1250 - 2500 cP
Pumping Temperature: 40 - 50°C
Pump Speed: 78 rev/min
